Newsletter of **Environmental, Disaster, and Crises Management Strategies**

Issue No.16 | January 2020

The January 24, 2020 Mw 6.8 Elazığ (Turkey) Earthquake

Professor **Efthymios Lekkas**

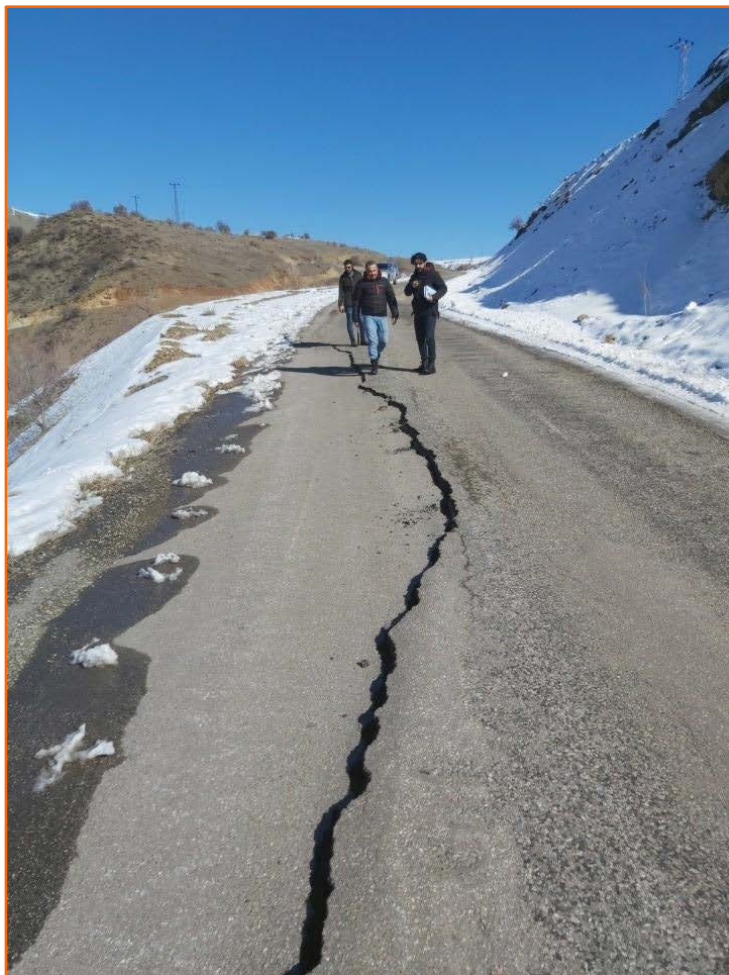
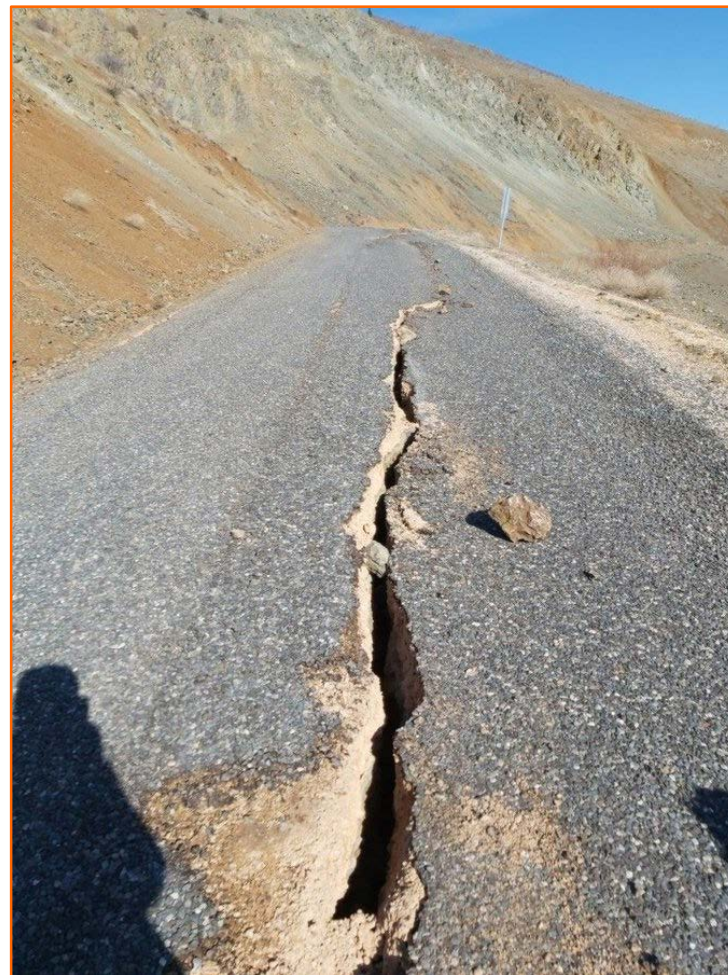
Ground cracks were induced in sites with existing instability. No surface faulting has been observed.
(From <https://twitter.com/tsancar/status/1221480276846616578>,
<https://twitter.com/tsancar/status/1222200667298770945>)

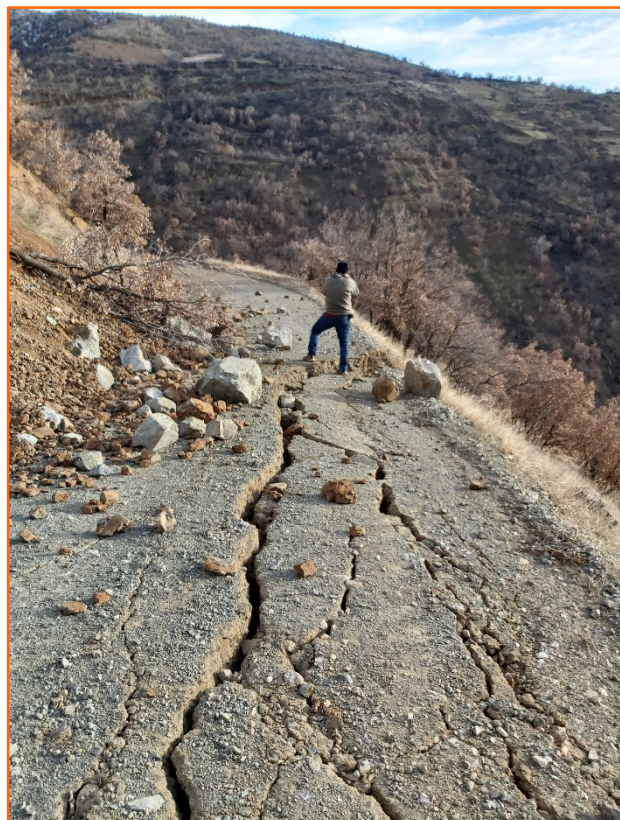
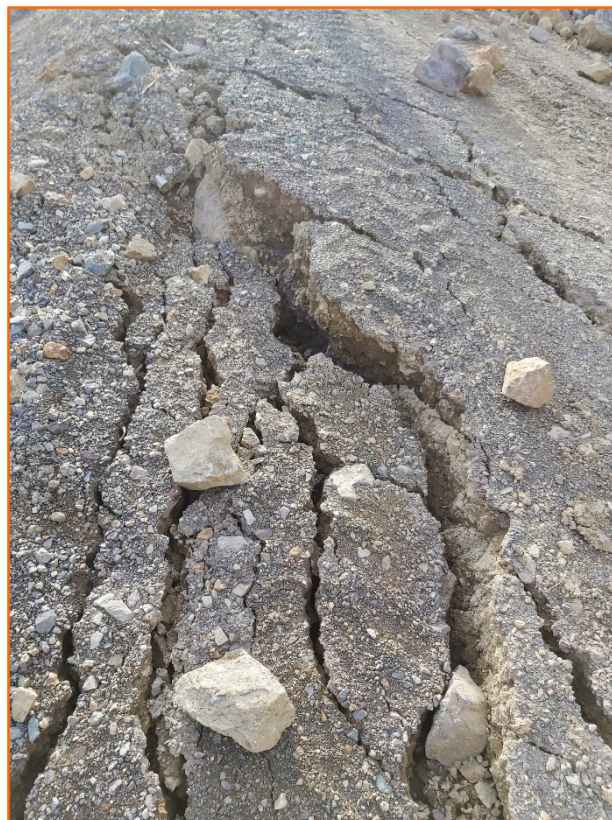
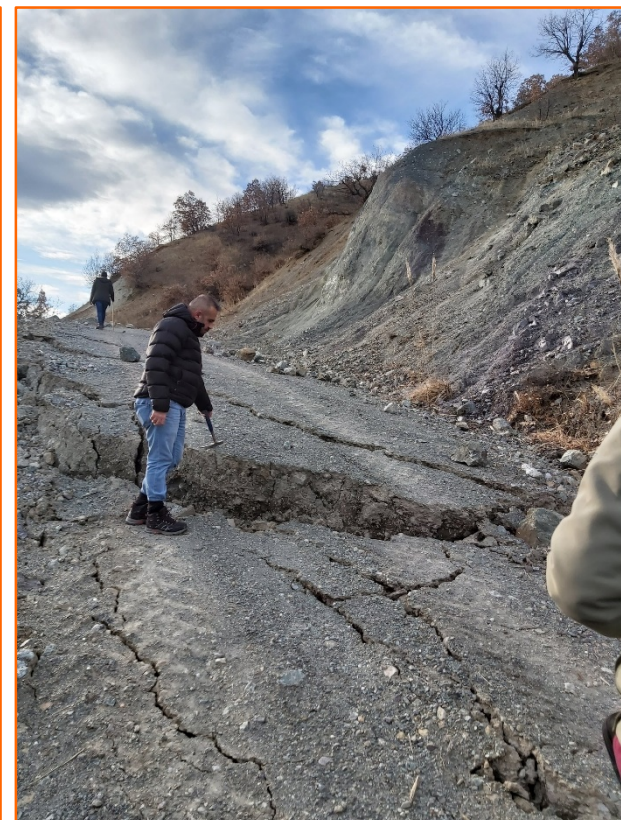
Ground cracks are attributed to the ground shaking close to gravitational movements observed in the affected area. Rockfalls and landslides were also observed in the same sites.

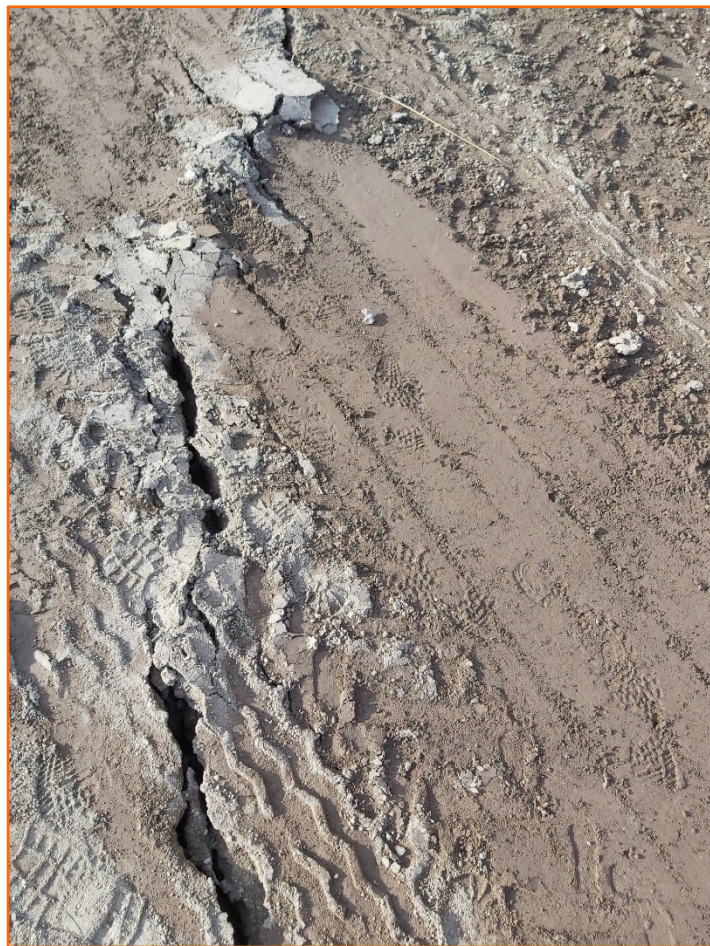
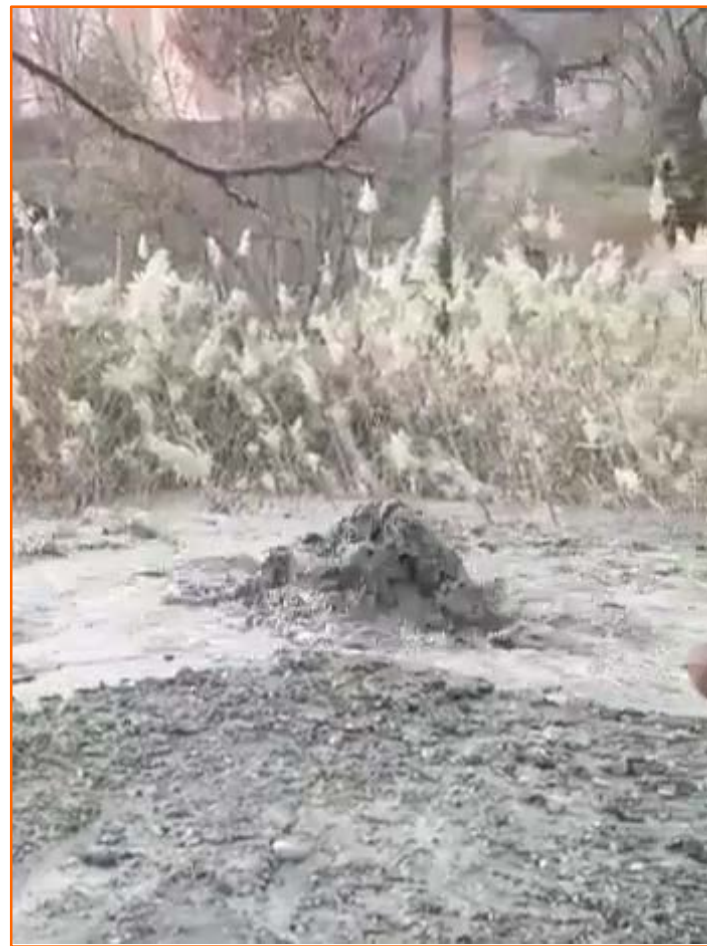
Liquefaction phenomena were generated along ground cracks. Hydrological anomalies comprised the formation of new hot spring within the Şiro River bed in Pütürge-Malatya area.

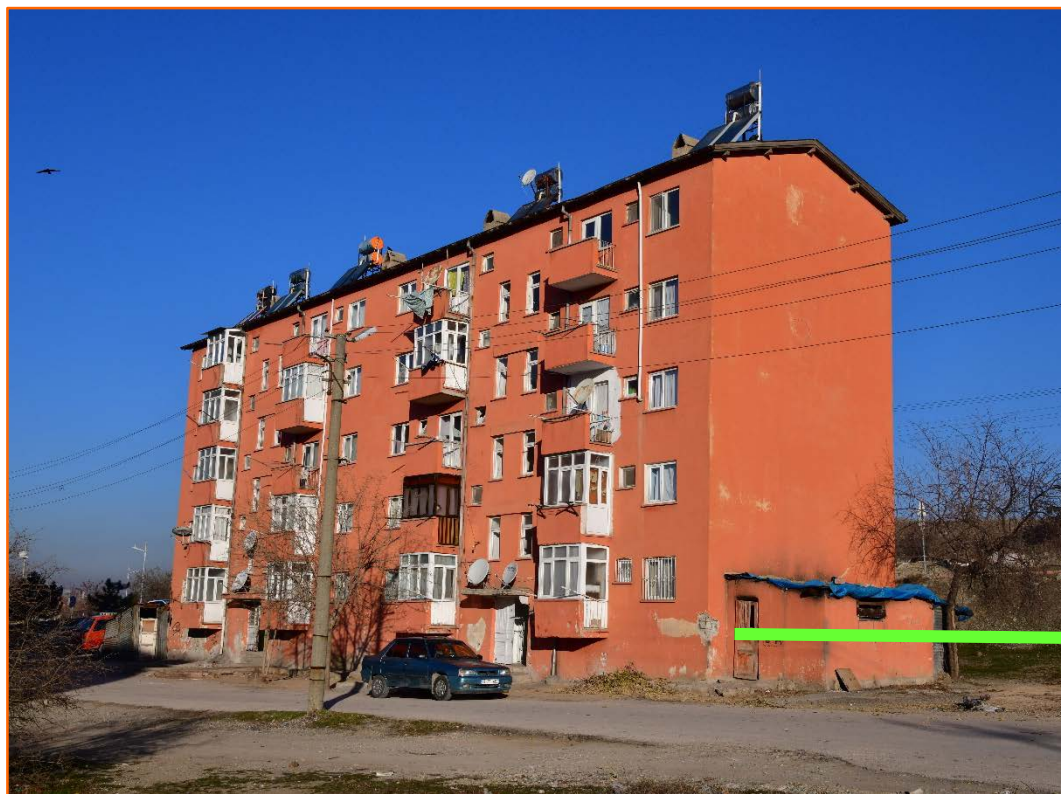
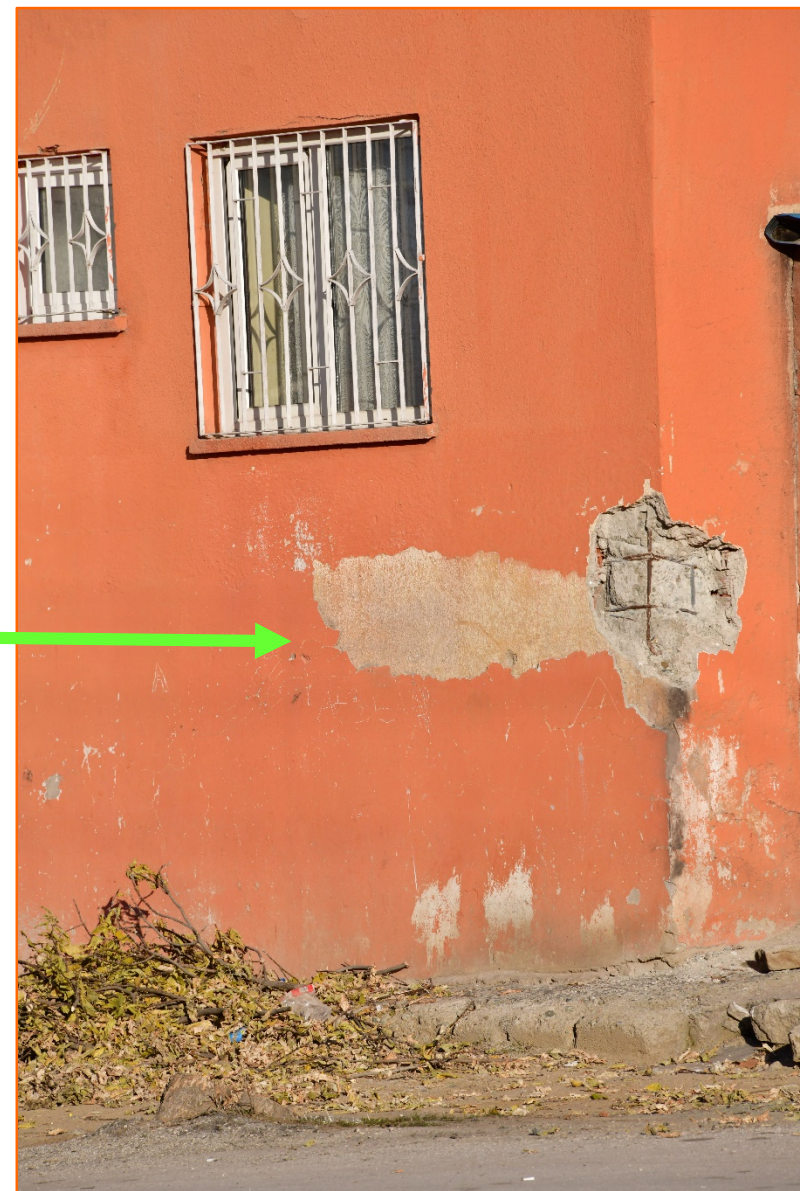
DAMAGE IN RC BUILDINGS (1/3)

Close to Elaziğ city, there is a residential complex consisting of about 10 5-storey residential buildings which are identical, based on a uniform horizontal ground. The damage observed was almost identical comprising column damage at a height of about 70 - 80 cm from the ground. This damage is attributed to poor construction quality in combination with the prevailing strong vertical component of the earthquake ground motion.

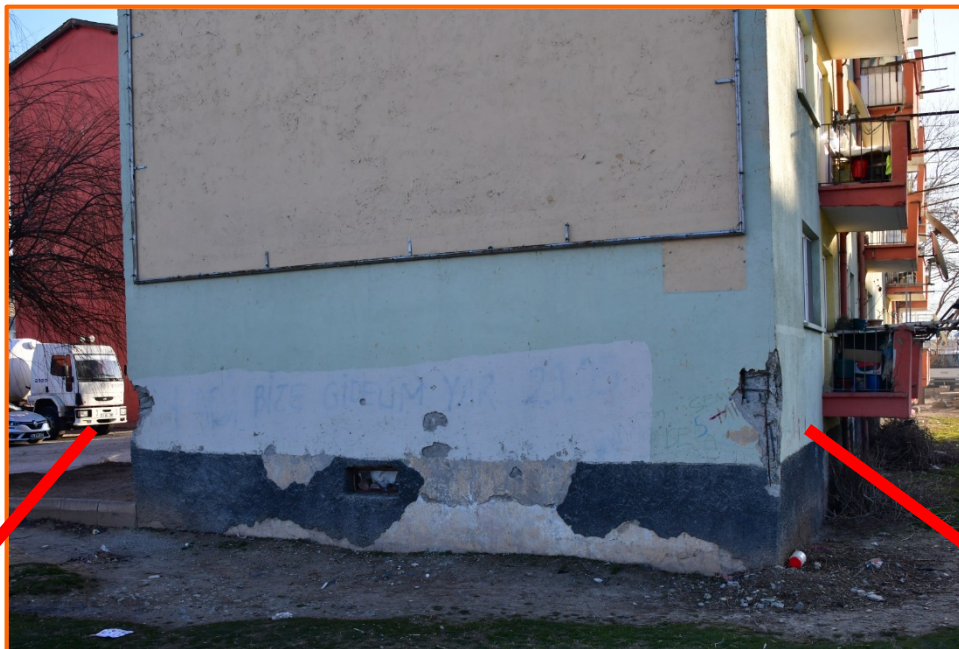
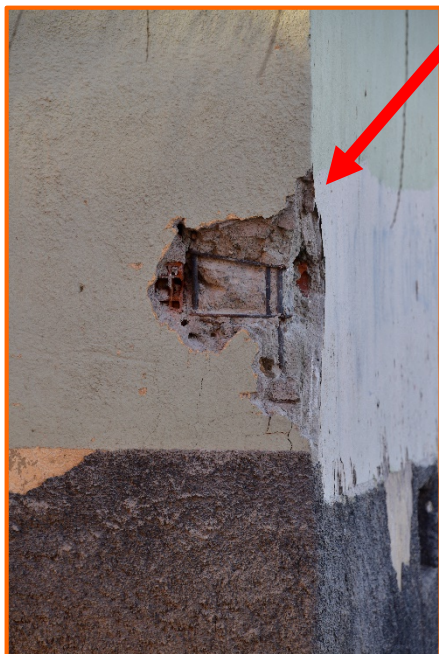
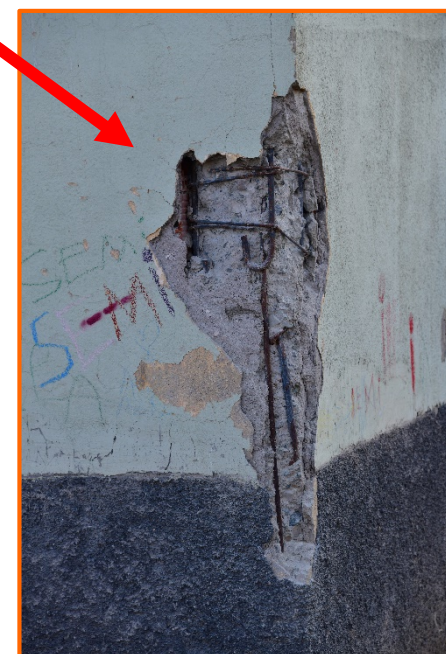
DAMAGE IN RC BUILDINGS (2/3)

Light damage comprise detachment of plaster pieces from the brick infill walls and detachment of pieces of concrete from the columns in the corners where the walls meet. The first damage is non-structural, while the second can adversely affect the antiseismic performance of the building by reducing the strength of the columns. The presented damage was generated in the lower parts of the building and more specifically in the ground floor.

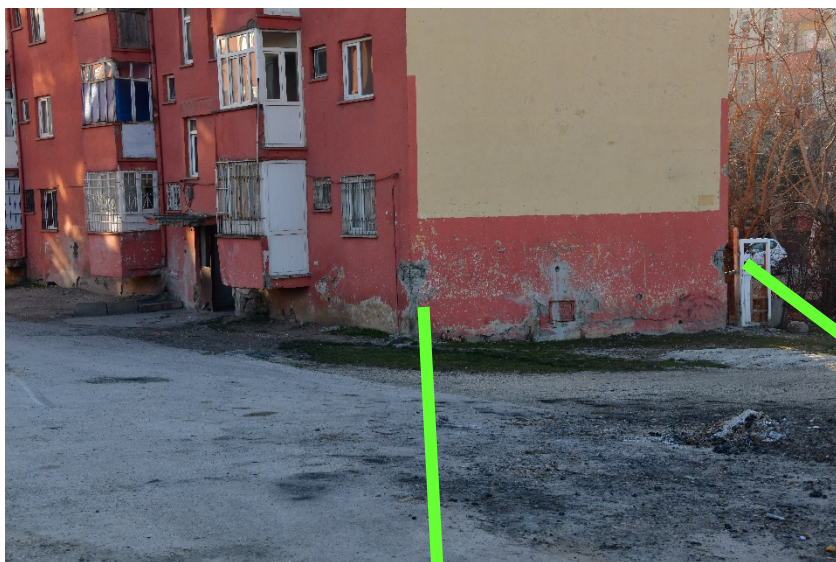
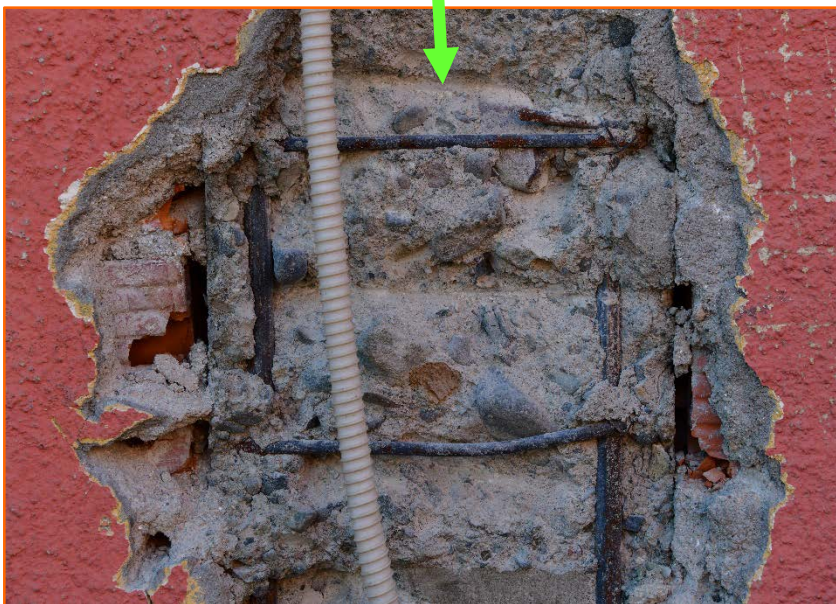
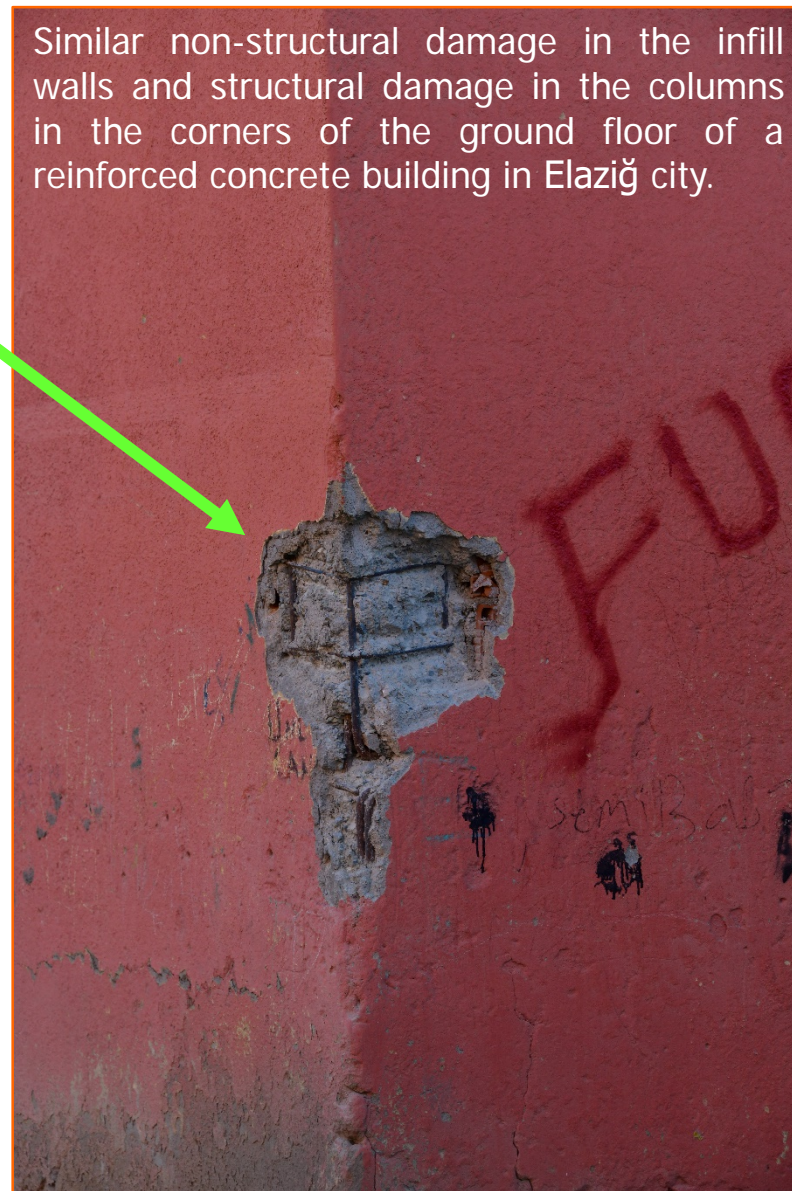
DAMAGE IN RC BUILDINGS (3/3)

Similar non-structural damage in the infill walls and structural damage in the columns in the corners of the ground floor of a reinforced concrete building in Elaziğ city.

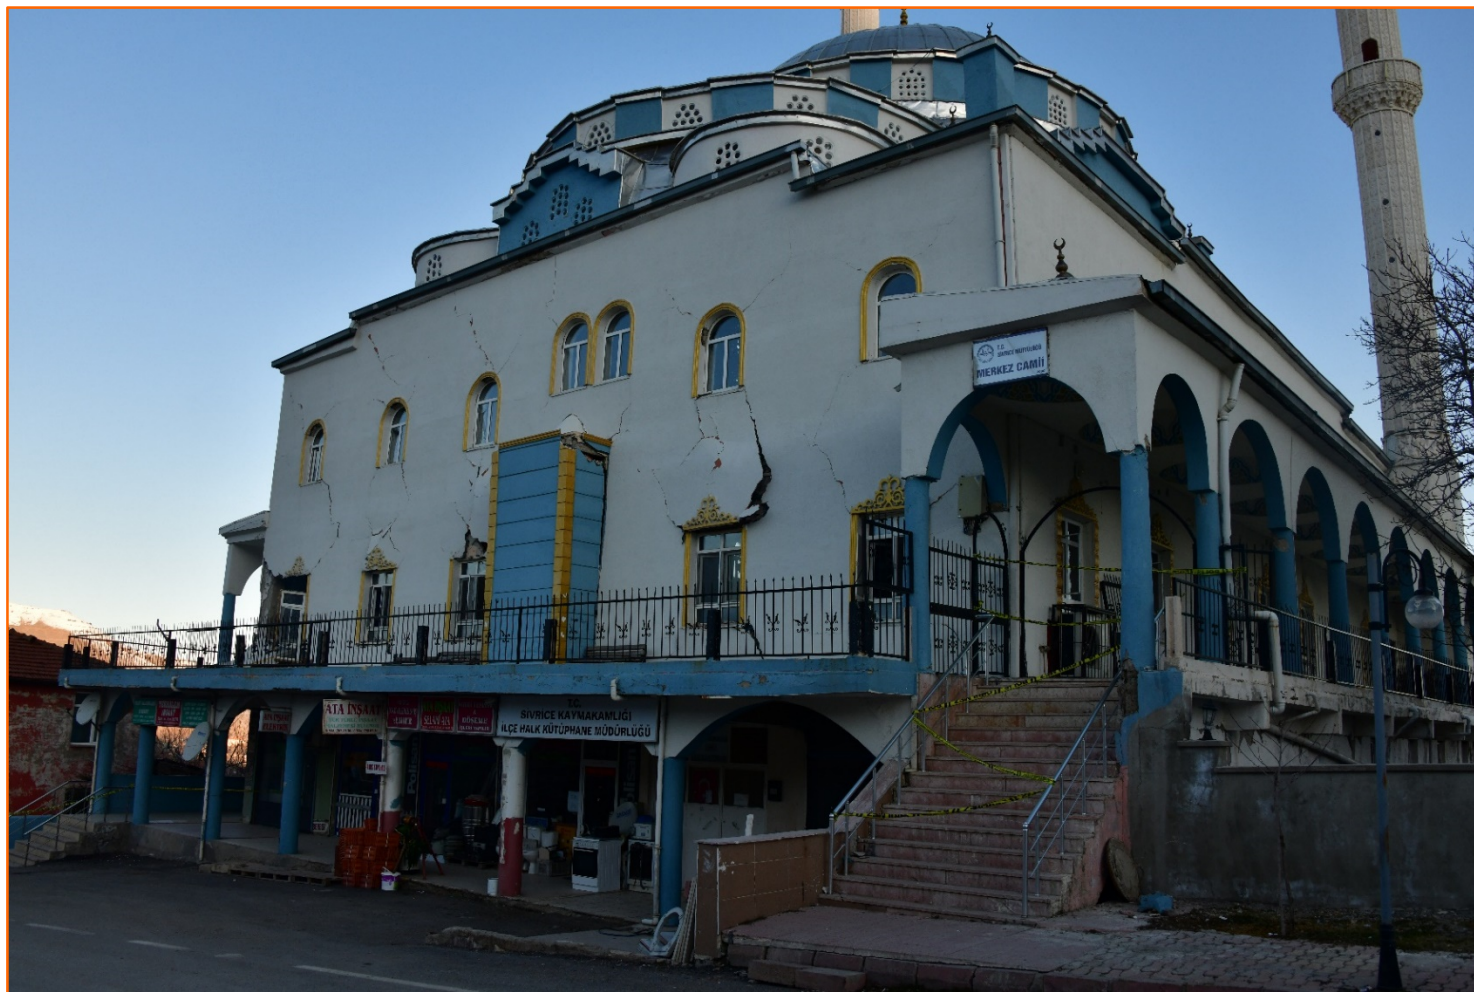
DAMAGE IN MOSQUES

The majority of mosques in the affected area were built with masonry techniques. The mosques generally feature one or more domes, the surrounding masonry walls and the adjacent minarets. In the affected areas of eastern Turkey, mosques suffered damage to the surrounding walls comprising detachment of plasters from the masonry walls, cracking and partial collapse of the masonry walls.

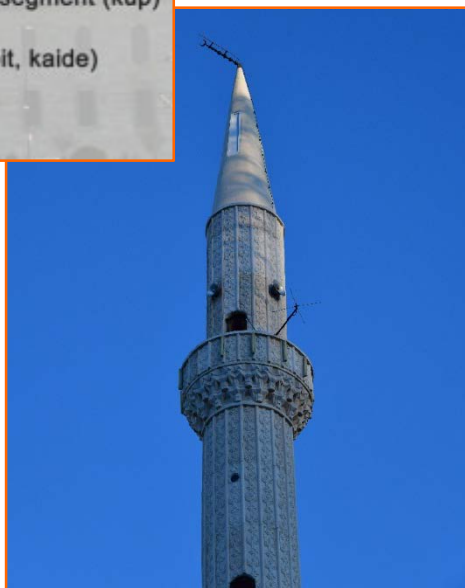
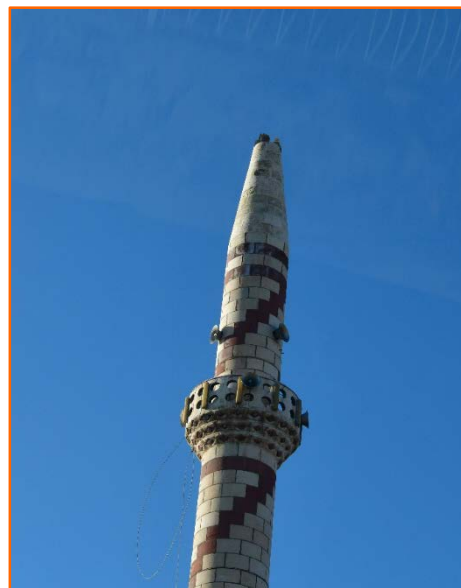
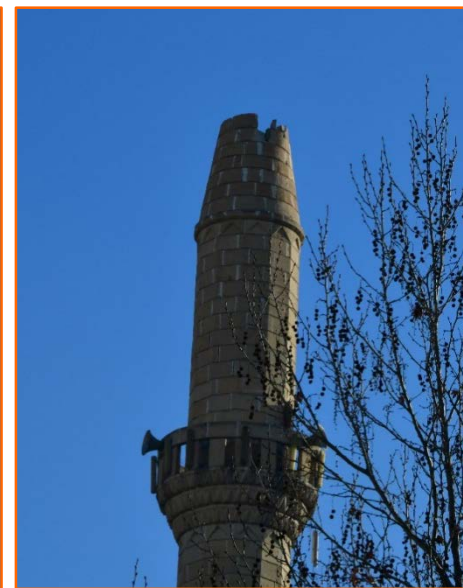
► Minarets in Elaziğ city

The masonry minarets were observed to fail in their upper part of their body, in their spire and in their end ornament. Most minarets in Elaziğ city present failure of the end ornament and collapse of the spire attributed to the action of the vertical component of the earthquake ground motion and the excitation of construction with small amplitude high seismic vibration of several cycles.

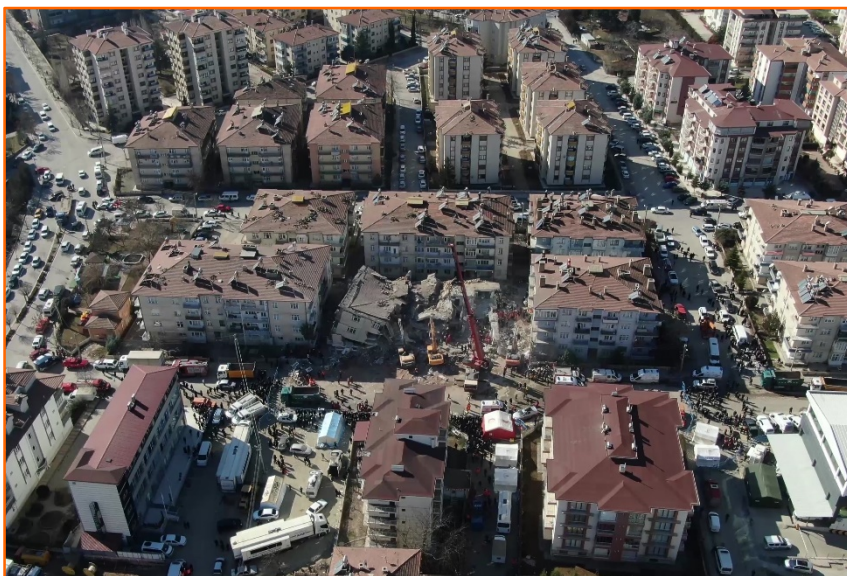
A partially collapsed building in Elazığ city. It appears to be identical in construction to adjacent buildings. The adjacent buildings remained almost intact by the earthquake.

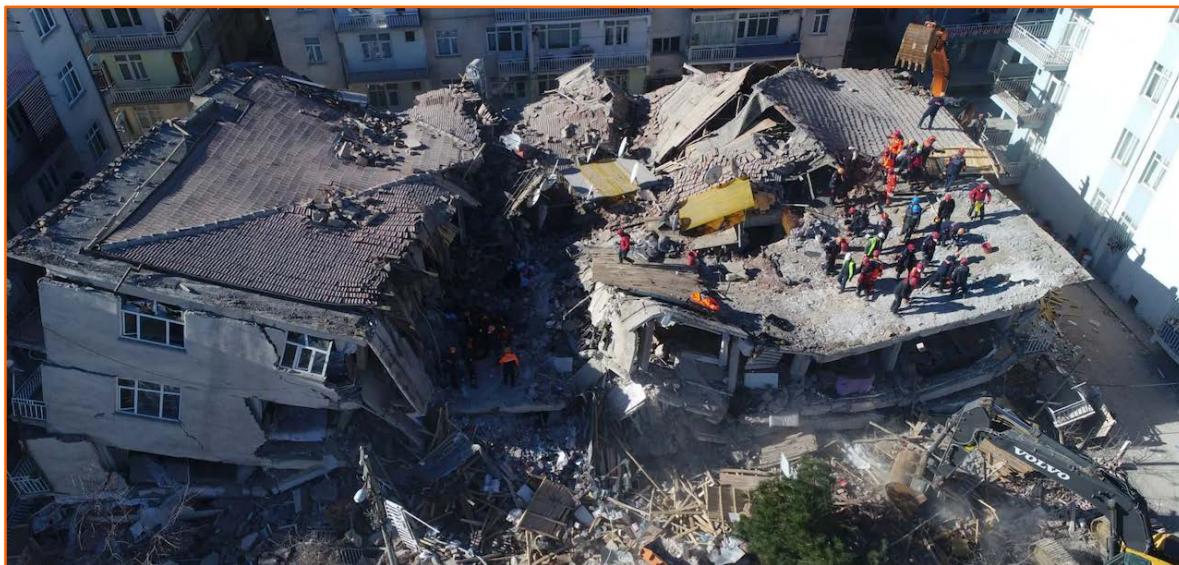
This building in Elazığ city collapsed almost within its foundation plan in the well known form of pancake. This indicates the prevalence of the vertical component of the earthquake ground motion, even in this strike-slip seismic event.

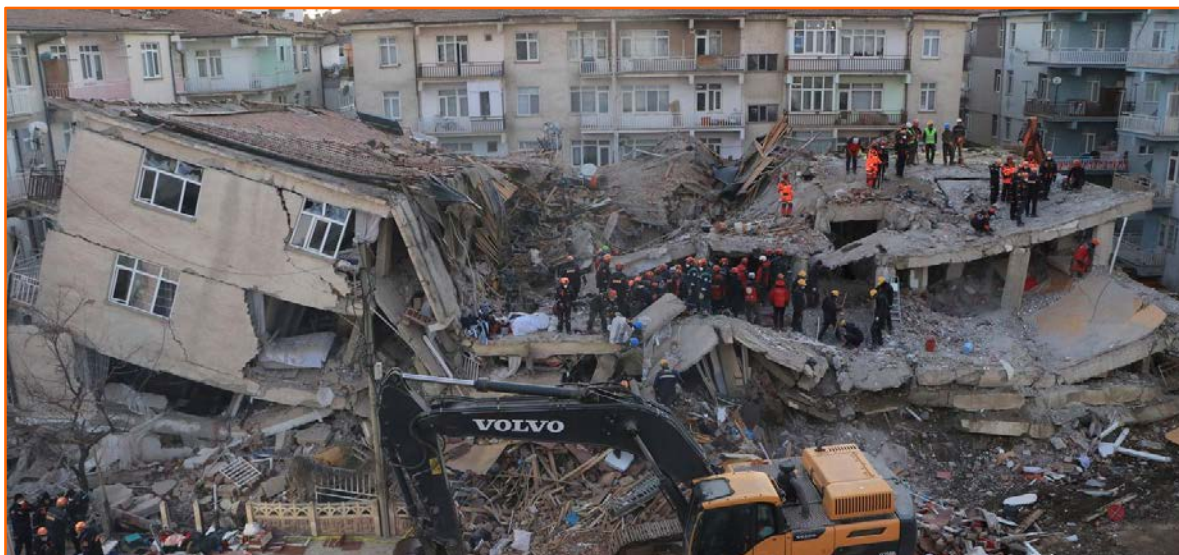
A macroseismic epicenter has been created close to the affected areas due to the adverse local soil conditions.

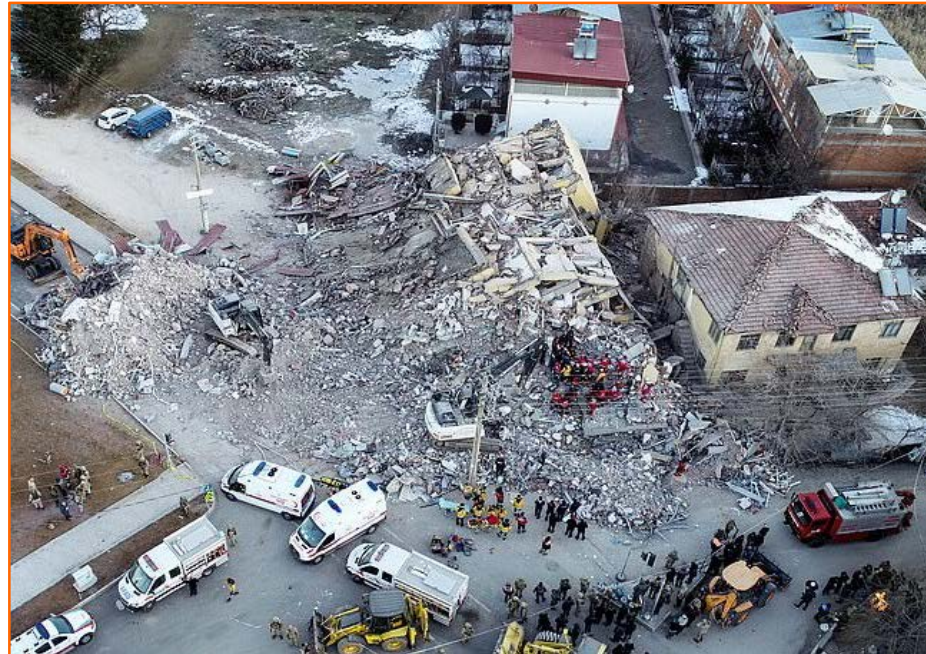
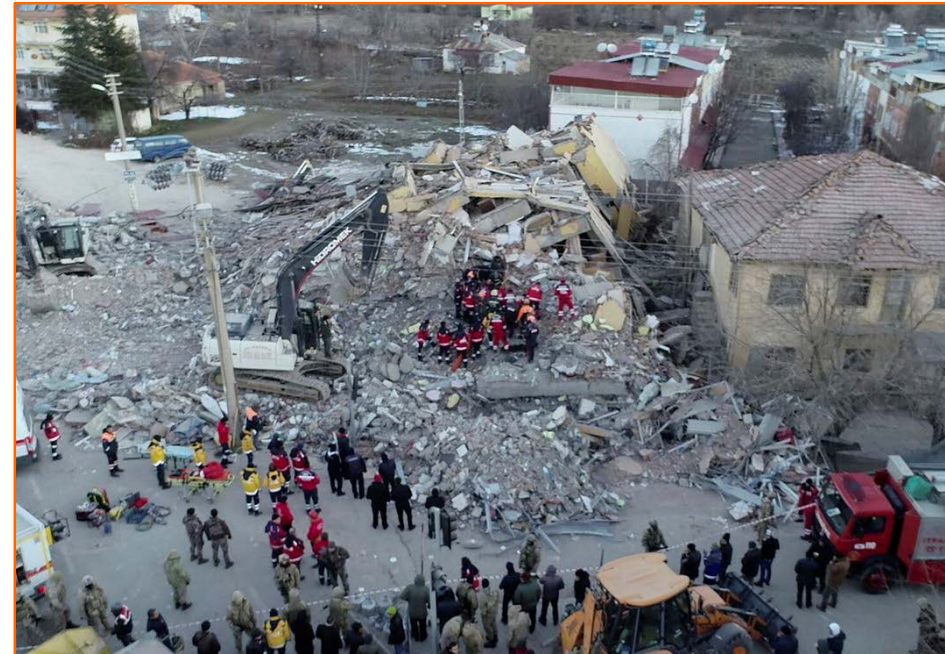
The presented residential building was among the totally collapsed buildings in Elaziğ city. The destruction was almost complete with debris leaving no gaps and empty spaces between them. The tangled mass of earthquake building debris reflects not only the strong seismic motion, but also the poor construction of buildings and the inadequate quality of construction materials.

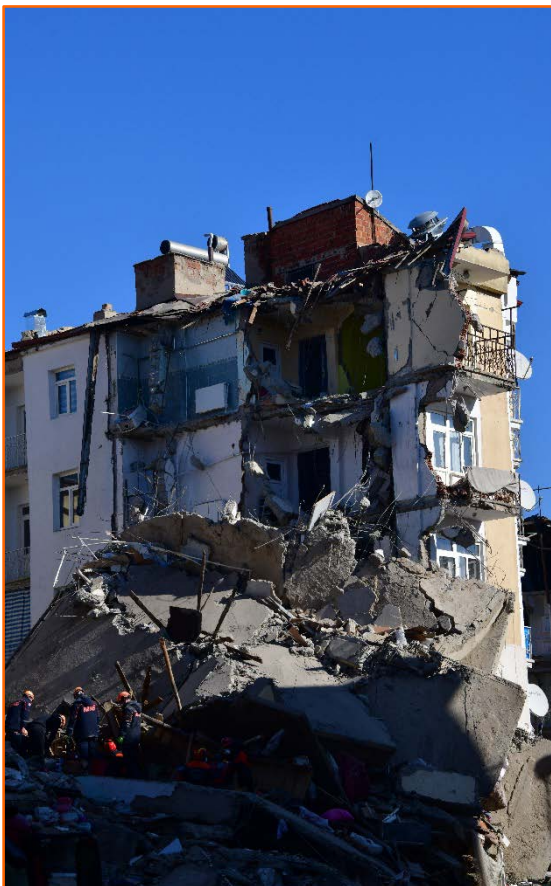
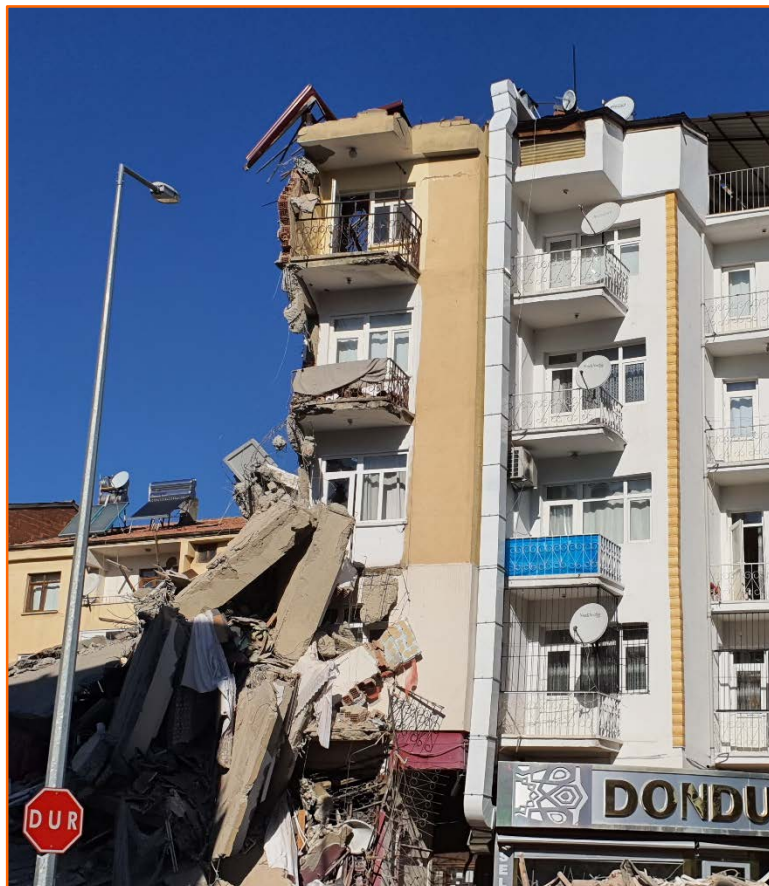
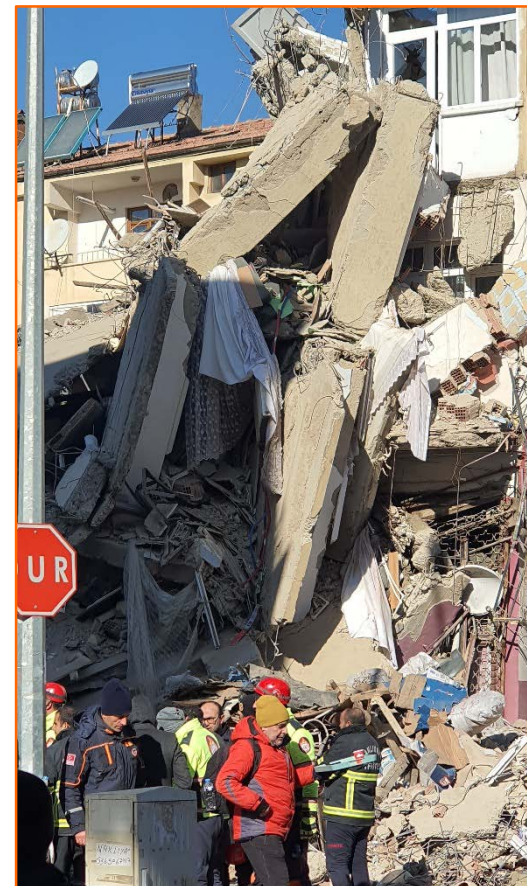
This multistorey reinforced concrete building in Elazığ city suffered partial collapse after the January 24, 2020 earthquake. Its remaining still-standing parts are practically undamaged. Spatial homothetic motions indicated the dominance of the vertical component of the earthquake ground motion.

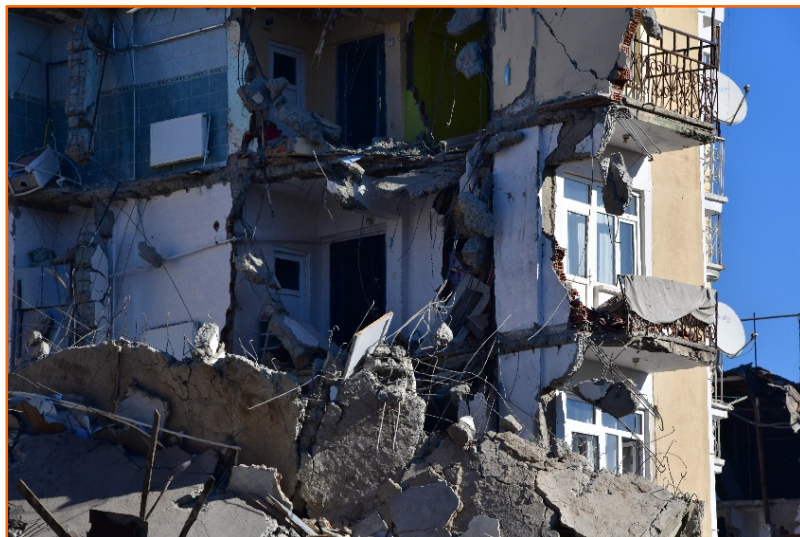
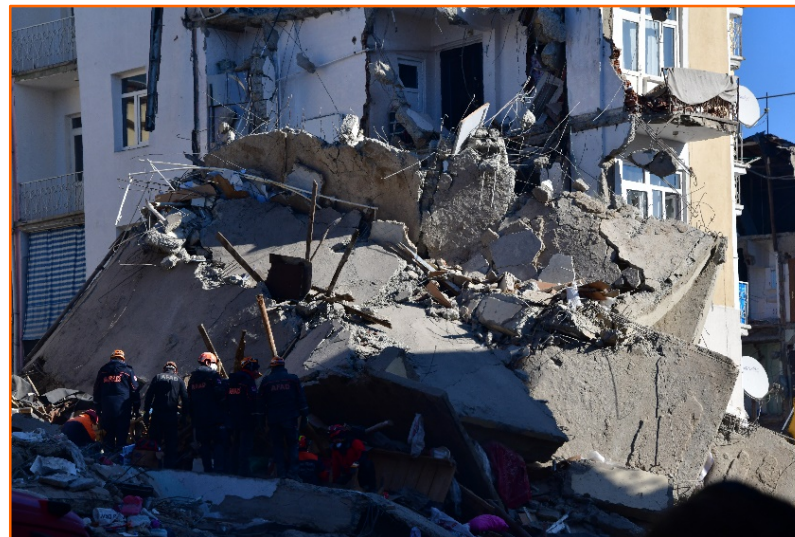
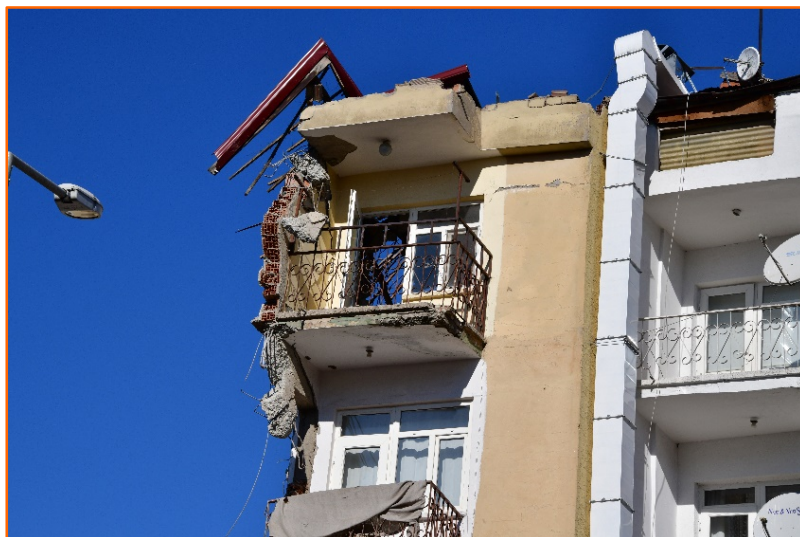
Details of the damage induced by the January 24, 2020 earthquake on the previously presented building

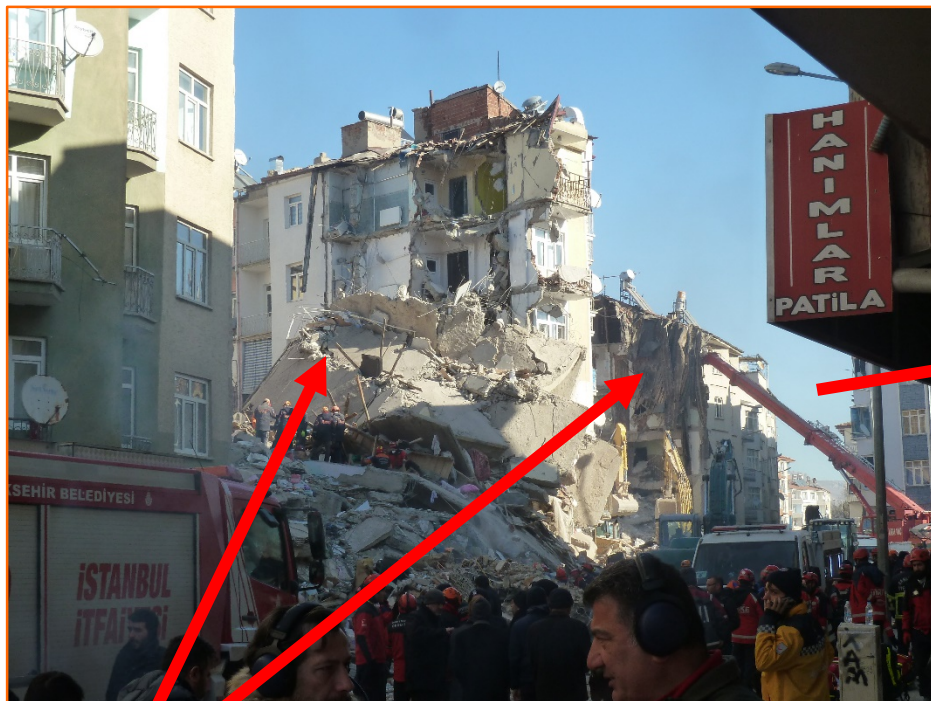
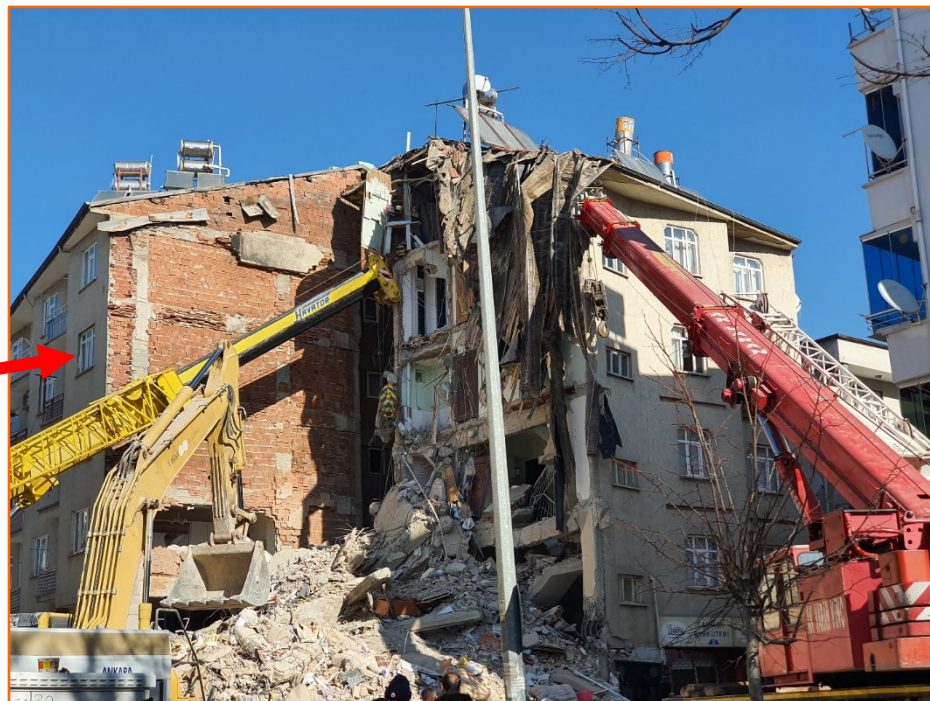
Two buildings in the same neighborhood in Elazığ city has suffered collapse of their southwestern parts. The direction of the collapse indicates not only the direction of maximum ground velocity and acceleration but also information about the microseismic and macroseismic epicenter.
