Newsletter of **Environmental, Disaster, and Crises Management Strategies**

Issue No.16 | January 2020

The January 24, 2020 Mw 6.8 Elazığ (Turkey) Earthquake

Professor **Efthymios Lekkas**

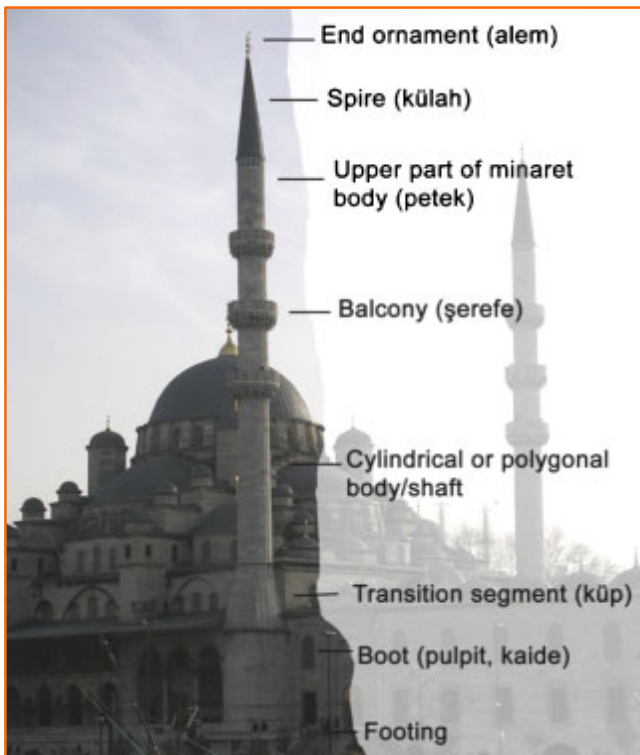
► Minarets in Elaziğ city

The masonry minarets were observed to fail in their upper part of their body, in their spire and in their end ornament. Most minarets in Elaziğ city present failure of the end ornament and collapse of the spire attributed to the action of the vertical component of the earthquake ground motion and the excitation of construction with small amplitude high seismic vibration of several cycles.

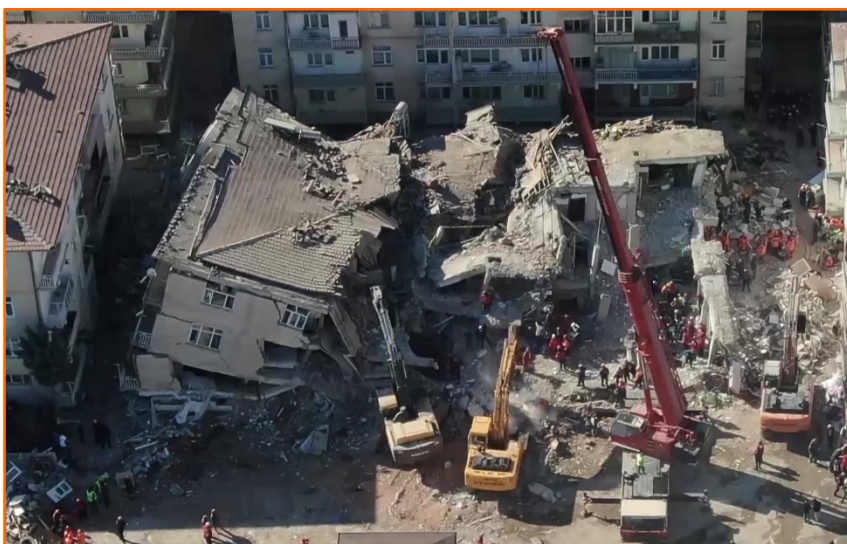
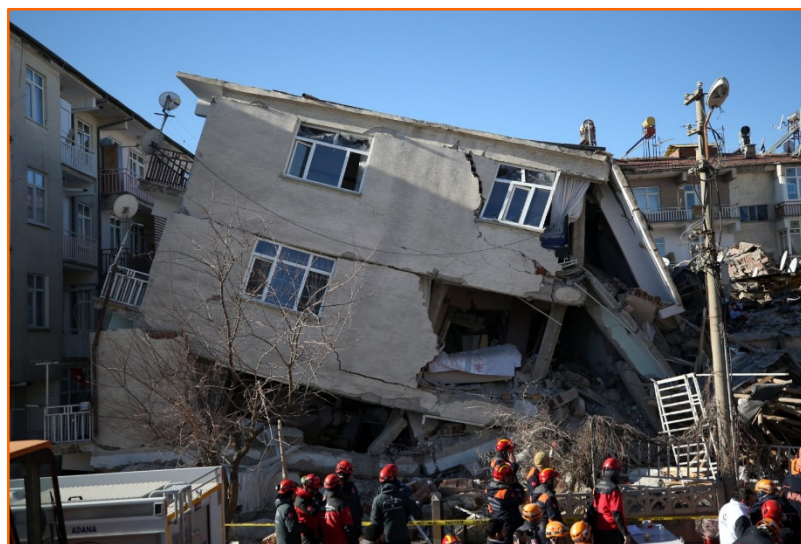
A partially collapsed building in Elazığ city. It appears to be identical in construction to adjacent buildings. The adjacent buildings remained almost intact by the earthquake.

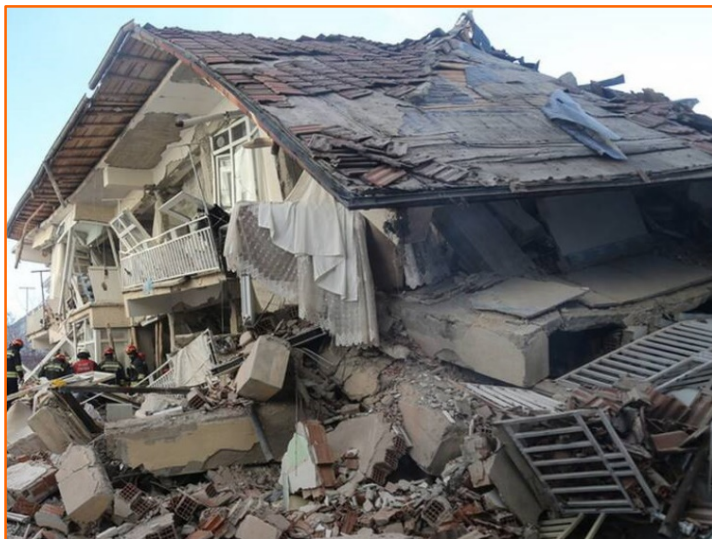
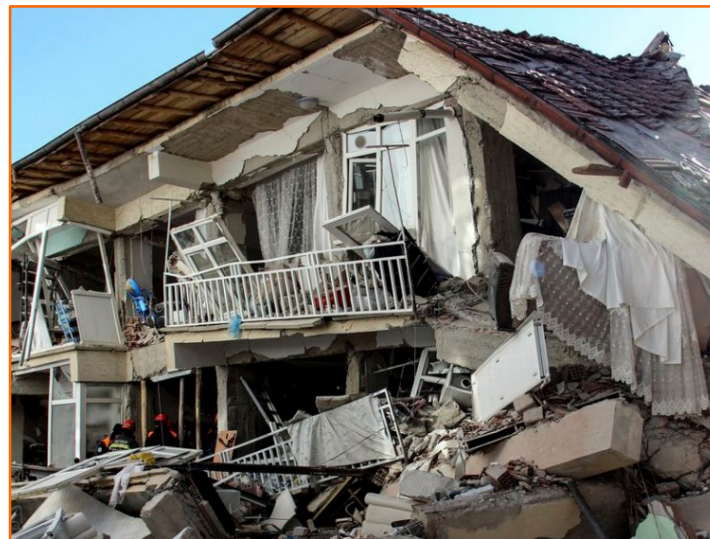
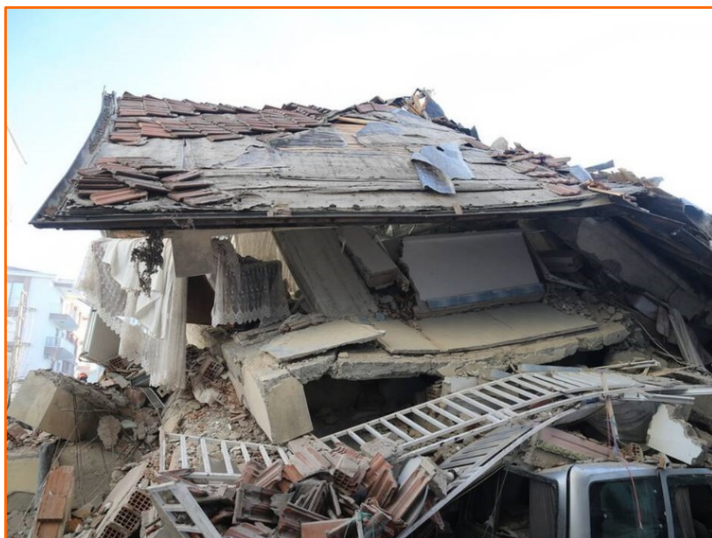
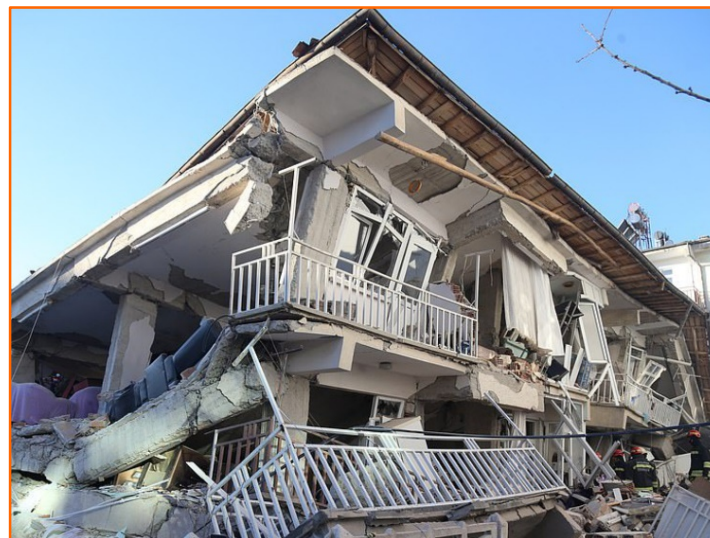
This building in Elazığ city collapsed almost within its foundation plan in the well known form of pancake. This indicates the prevalence of the vertical component of the earthquake ground motion, even in this strike-slip seismic event.
